# **Monogram Refrigerator Technician Manual**

## **1988 Through 1991 Models Refrigeration Units**

# MONOGRAM REFRIGERATORS

1988 THRU 1991 MODELS

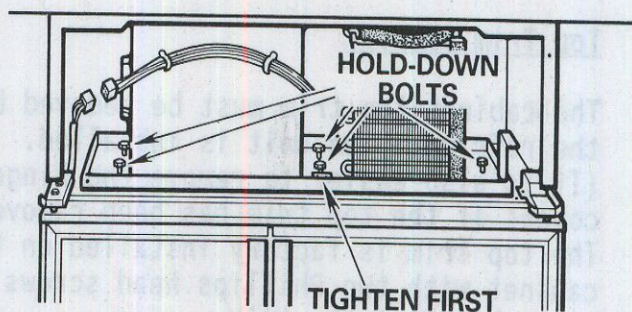
Five hold down bolts are used to secure the refrigeration unit to the cabinet assembly. The 7/16" hex-head bolts are necessary to seat the air duct gasket (between the cabinet and the refrigeration unit). When installing the refrigeration unit, first tighten the two center bolts and then the three outer bolts to properly seat the gasket.

If the outside bolts are tightened first the refrigeration unit may bow up in the center and provide an air leak path due to an unsealed gasket.

Improper sealing of the refrigeration unit to the cabinet assembly could cause a warm temperature condition, high compressor run time, and possible sweat problems inside the refrigerator and on top of the cabinet assembly.

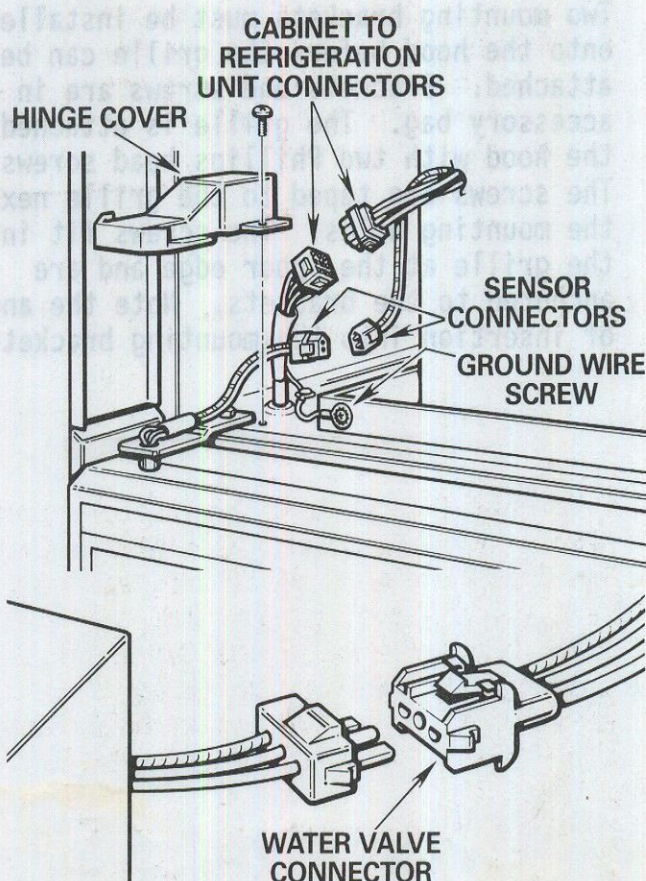
The water valve harness is connected to the water valve at the right side. A connector on the water valve is connected to the harness extending from the refrigeration unit - - behind the condenser.

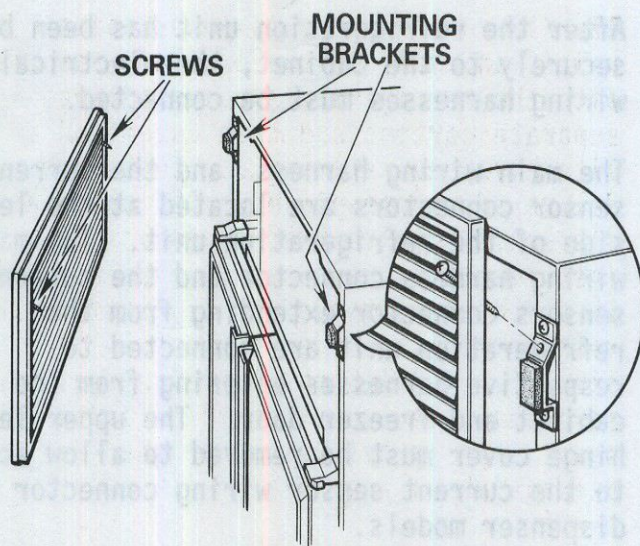
Two mounting brackets must be installed onto the hood before the grille can be attached. Brackets and screws are in the accessory bag. The grille is attached to the hood with two Phillips head screws. The screws are taped to the grille next to the mounting holes. The screws fit into the grille at the upper edge and are anchored to the brackets. Note the angle of insertion into the mounting brackets.

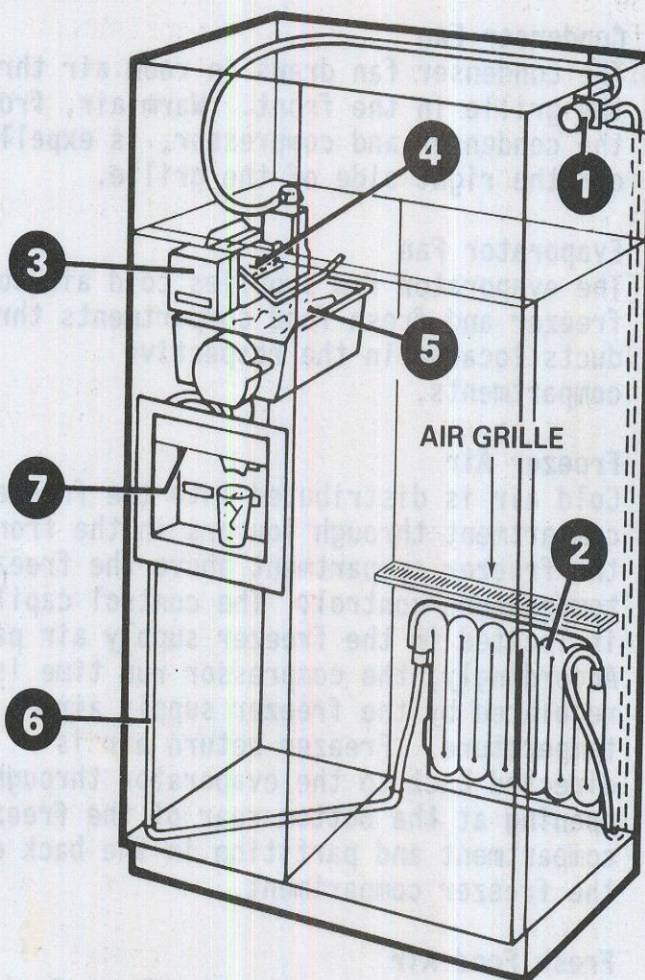
3. Ice maker
4. Ice cube mold.
5. Auger and ice bucket assembly.
6. Water tubing inside freezer door.
7. Dispenser Recess Assembly.

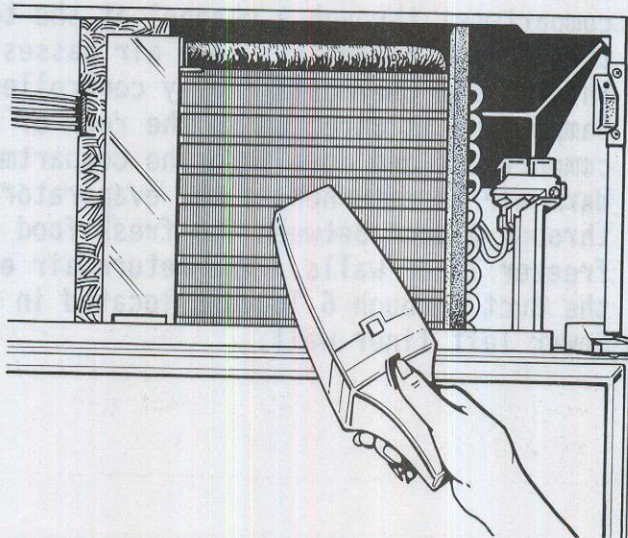
The condenser, located in the refrigeration unit compartment, should be cleaned at least once a year for efficient operation. After removing the grille, the surface of the condenser to be cleaned is exposed at the right front of the unit.

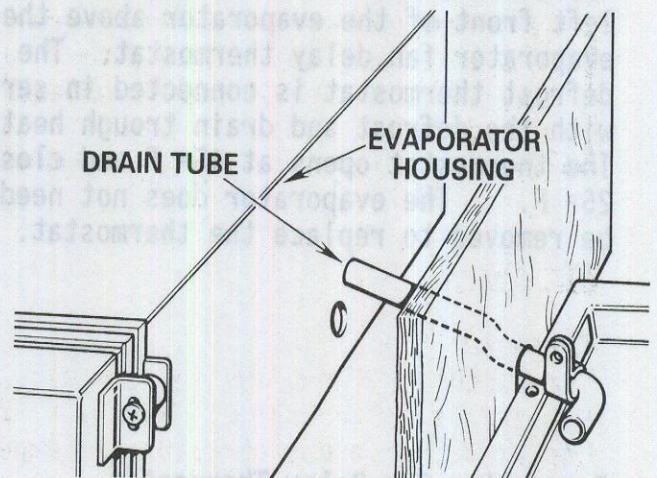
Defrost water from the drain trough, under the evaporator, flows through a tube that extends to the defrost water pan at the right side of the refrigeration unit. In addition to warm air from the condenser fan flowing across the pan, an auxiliary condenser, positioned under the bottom of the pan, helps evaporate the accumulated defrost water.

If the drain tube is not positioned on the drain spout correctly, defrost water can spill into the fresh food compartment. It will usually appear as very clear clean water at the bottom of the fresh food air return ducts and on the compartment floor. After several defrosts have occurred, this drain water will accumulate enough to drain out the bottom of fresh food door and onto the floor. To correct this condition, reposition the drain tube on the drain spout and seal around it with permagum.

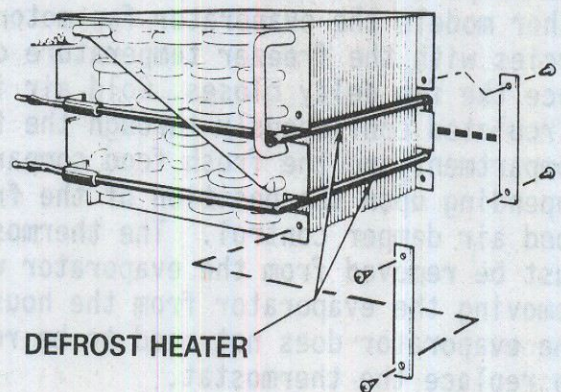
The defrost heater is positioned into the right side and rear of the evaporator and held securely by brackets at each end. To replace the defrost heater, the evaporator must be removed from the evaporator housing.

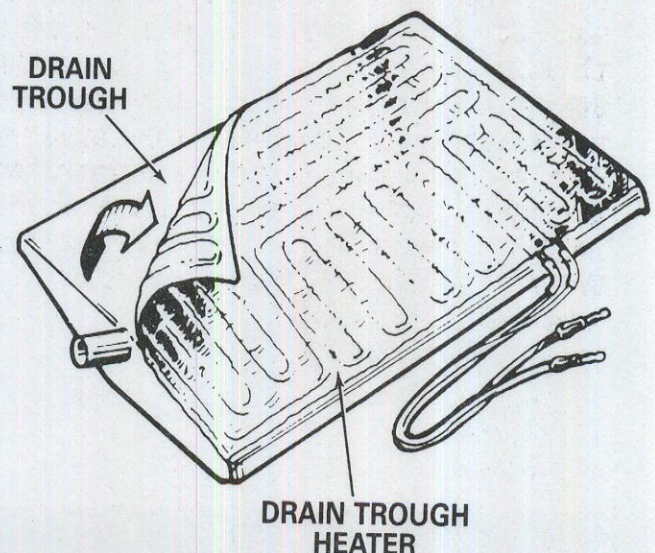
The drain trough heater is located on the bottom of the drain trough. The heater is imbedded in an aluminum sheet, and the sheet adheres to the bottom of the trough. The heater can be removed by peeling the aluminum sheet off the drain trough. To replace the drain trough heater the evaporator must be removed.

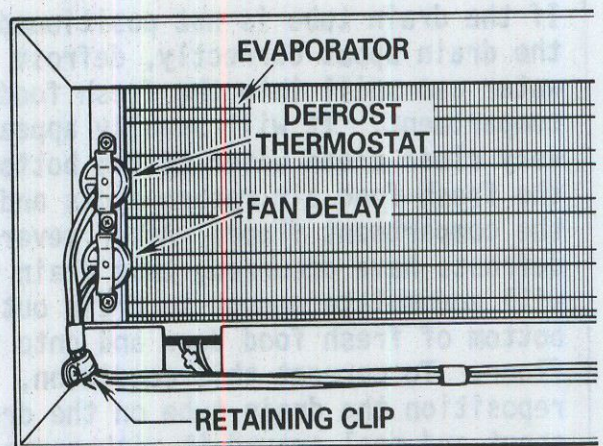
The defrost thermostat is mounted to the left front of the evaporator above the evaporator fan delay thermostat. The defrost thermostat is connected in series with the defrost and drain trough heaters. The thermostat opens at 45° F and closes at 25° F. The evaporator does not need to be removed to replace the thermostat.

All models are equipped with an evaporator fan delay thermostat mounted to the front of the evaporator. The fan delay is connected in series with the evaporator fan motor. The thermostat closes at 25° F and opens at 45° F. The thermostat delays the fan for about 10 minutes after a defrost cycle to allow the evaporator to cool down. On **EK MODELS** once the fan delay thermostat closes, the evaporator fan continues to run until the next defrost cycle, even though the temperature control opens. On all other models the evaporator fan motor cycles with the freezer temperature control once the fan delay closes. Cold air is circulated continuously through the freezer compartment and the fresh food compartment depending upon the position of the fresh food air damper control. The thermostat must be removed from the evaporator when removing the evaporator from the housing. The evaporator does not need to be removed to replace the thermostat.

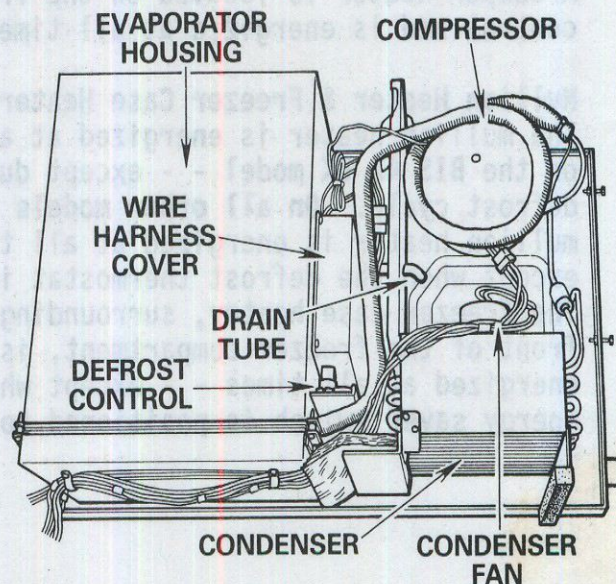
The compressor is located behind the condenser and condenser fan on the right side of the refrigeration unit. To access the refrigeration system, a Service Valve must be attached to the low pressure process tube extending from the compressor case. For diagnosis of the refrigeration system, use the standard Compressor Capacity Test or the Leak-Restriction Test, as required.

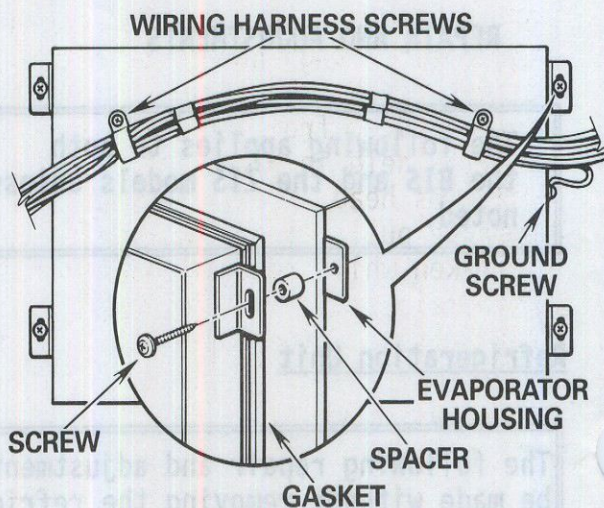
The evaporator housing front cover must be removed before components in the housing can be repaired or replaced. Wiring attached to the front cover must be removed and the ground screw disconnected prior to removing the front cover.

The cover is held in place with four bolts. The bolts extend through brackets on the front cover and are attached to brackets on the evaporator housing. Spacers are used between the brackets to maintain the proper spacing of the front cover to the evaporator housing. A gasket attached to the front cover provides a seal to the evaporator housing. If upon reassembly, the gasket compression is not enough to provide a good seal, remove the spacers and tighten the bolts slightly to seat the gasket to the housing.

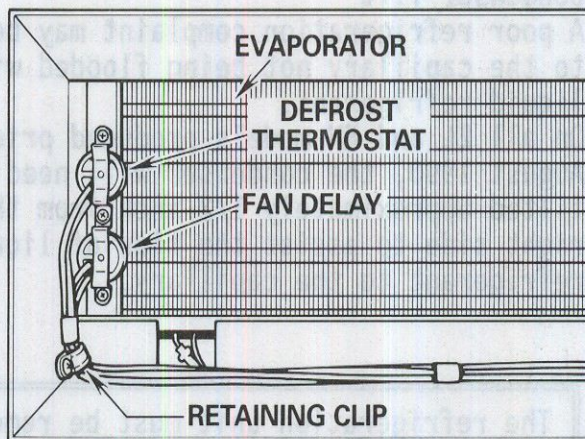
The defrost thermostat and fan delay thermostat are mounted, one above the other, to the front of the evaporator. Both thermostats are accessible when the evaporator fan assembly has been removed.

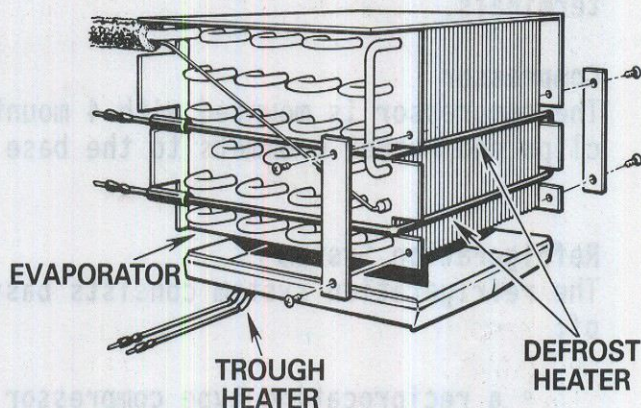
The defrost heater is positioned into the right side and rear of the evaporator and secured by brackets at each end.

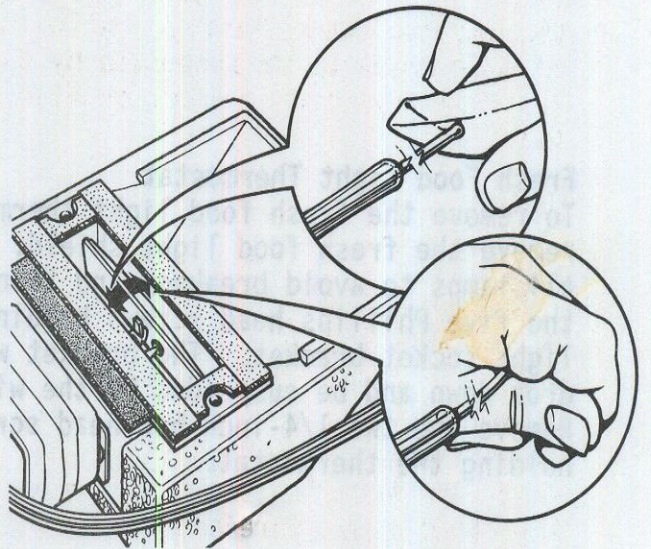
The operation of the damper control can be tested by holding an ice cube in contact with the exposed end of the capillary. The damper should slowly close in response to the cold temperature of the ice cube. Then, while grasping the end of the capillary by hand, the damper should open.

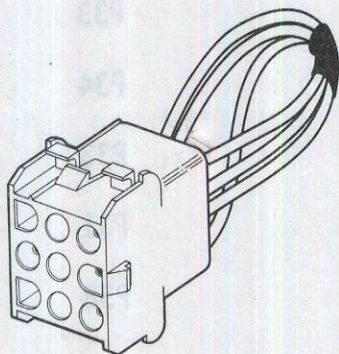
The adapter plug connects to the refrigeration unit wiring harness located on the left side of the refrigeration unit. The power cord should then be plugged into a 115 VAC outlet. No other appliance should be in the circuit.

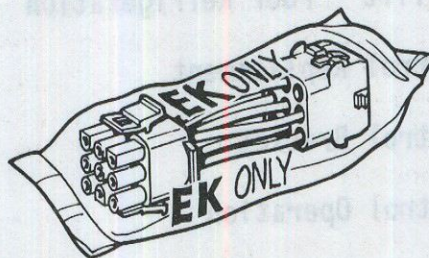
An adapter plug is provided in the Moisture Kit and should be used on EK models ONLY. The plug is designed to energize the freezer case heaters only when the compressor is running.

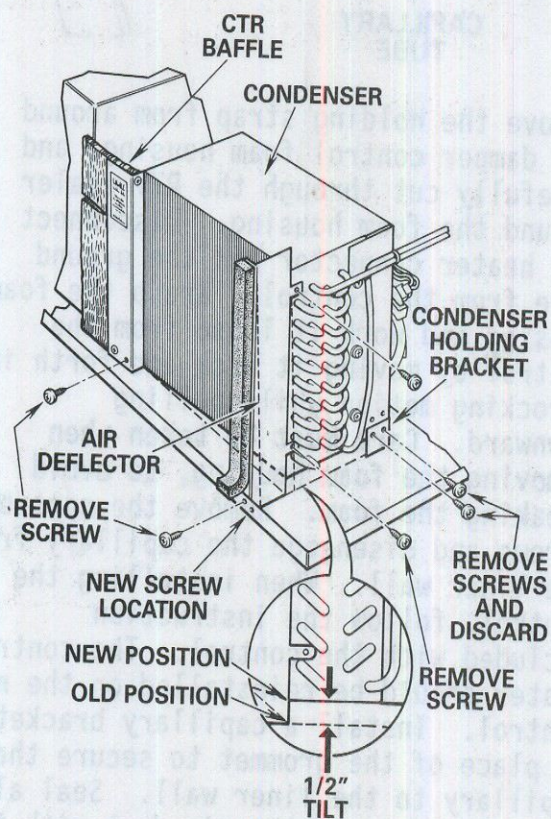
Tilted Condenser

A mysterious, poor refrigeration complaint on some Monogram, **BISB/W 42 EL** and **ZISB/W 42 EM** model refrigerators, produced prior to **August 1990**, may be due to the size of the condenser and the air circulating through the condenser. Good indicators that this is the problem are: (1) the top passes of the condenser will be abnormally cool, and (2) the refrigeration system low side pressure will be in a slight vacuum (giving the symptom of a leak, restriction). To confirm the diagnosis, unplug the condenser fan. Within two to three minutes the top passes of the condenser should begin to feel warm and the system pressure should begin to rise. On these models, include this test as part of the sealed system diagnosis and try this first. It could save considerable time and prevent misdiagnosis. To correct this condition, the condenser must be raised approximately 1/2-inch at the right side, resulting in a tilted position.

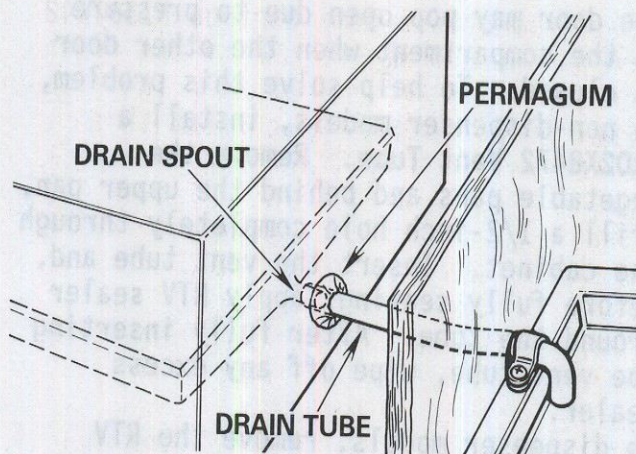
Drain Tube Location

An unusual amount of water in the bottom of the fresh food compartment may be due to a loose or misaligned drain tube. The defrost water will drip down the fresh food air return duct rather than into the drain pan. Very clear, clean water will accumulate at the bottom of the fresh food air return louvers and on the compartment floor. After several defrost cycles, this drain water will accumulate and drain out the bottom of fresh food liner and onto the floor. Reposition the drain tube on the drain spout and seal around it with permagum.

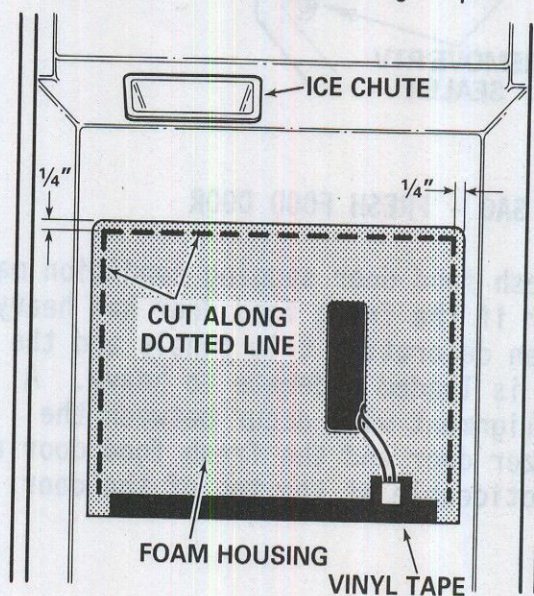
A dispenser recess foam housing is used on models in production after August, 1990. The housing completely surrounds the dispenser mechanism inside the freezer inner door to help eliminate moisture problems in this area. Component parts are not accessible with the rear access cover removed without cutting a window in the foam housing. Cut the housing as shown below, using a utility knife and limit the penetration of the foam to 1/4-inch in depth. Pull the panel forward and allow it to hang by the vinyl tape. Reseal the foam housing window with masking tape.

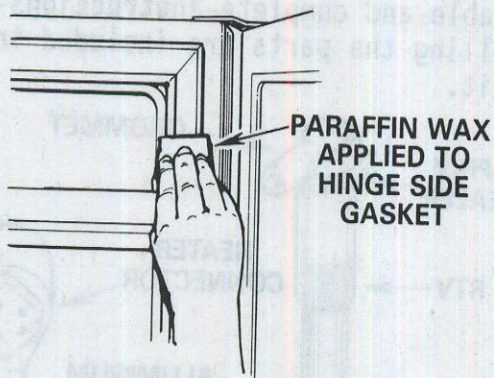
Doors staying open, can sometimes be caused by a door gasket scrub condition on the hinge side of the door. Door gasket scrubbing at the hinge side can be corrected with an application of paraffin wax. Rub a piece of pure paraffin on the sealing surface of the gasket - from top to bottom (once or twice) - to uniformly coat the gasket with a film of wax.

Paraffin wax is preferred over petroleum jelly, because it last longer between applications and is less noticeable when applied.

A scrubbing condition can eventually cause the sealing surface of the gasket to fold over and bind the door - preventing it from closing and/or sealing. If this occurs:

1. Warm the entire length of the gasket with a heat gun. (Due to the intense heat from the heat gun, care must be taken to avoid melting the gasket.)
2. Reform the gasket to its original position while it is warm.
3. After the gasket has cooled, coat the gasket sealing surface with paraffin wax.
4. Check for a smooth wiping action as the door is closed and opened.
5. Advise the customer that the wax is necessary to keep the gasket from binding and should not be removed.
